NASA/TM—2000-210473

NDE Methodologies for Composite Flywheels Certification

George Y. Baaklini and Kevin E. Konno
Glenn Research Center, Cleveland, Ohio

Prepared for the
2000 Power Systems Conference
sponsored by the Society of Automotive Engineers
San Diego, California, October 31–November 2, 2000

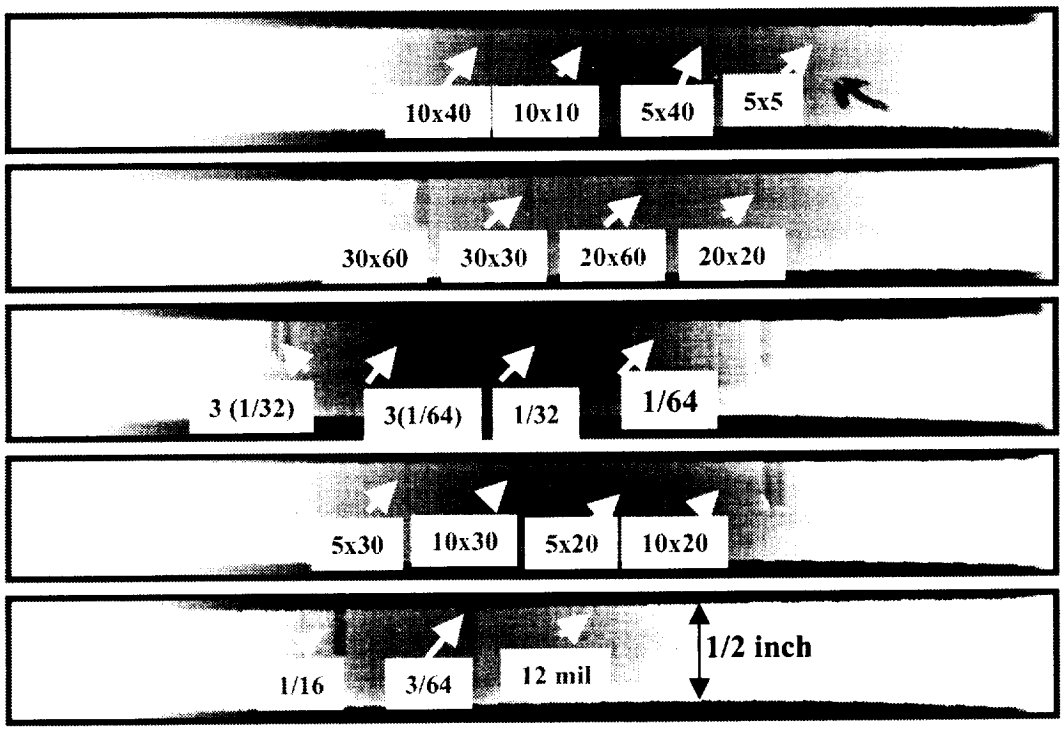
Ring Standard - Table I shows all the NDE findings taken on two standard rings by using ultrasonic TT and PE methods, conventional as well as microfocus radiography and 420KeV and 3 MeV x-ray CT methods. The microfocus radiography images of one of the standard ring are shown in figure 6. The ultrasonic images are shown in figures 7 and 8. From table I findings and figure 6 images microfocus radiography was demonstrated to be a viable NDE technique to detect EDM notches and drilled holes down to a 125x125 μm notch and 300 μm drilled hole. Conventional radiography was capable of detecting EDM notches down to 250x750 μm and drilled holes down to 780 μm in diameter. However, conventional radiography is capable of detecting metallic inclusion down to 125x125 μm. Computed tomography findings demonstrate that EDM notches down to 125x125 μm and drilled holes down to 300 μm in diameter can be easily detected by 420KeV as well as by a 3 MeV systems. The PE ultrasonic method was found to be capable of detecting EDM notches down to 125x125 μm and drilled holes down to 300 μm in diameter. TT method was capable of detecting EDM notches down to 125x1000 μm and drilled holes down to 780 μm in diameter.

Fig. 6 - Microfocus radiography of one NDE ring standard showing the capabilities of detection down to 125x125 μm (5x5 mils) notch. Measurements shown are in mils and images shown are prints of 5 radiographs taken in direct contact with the ID of the ring.

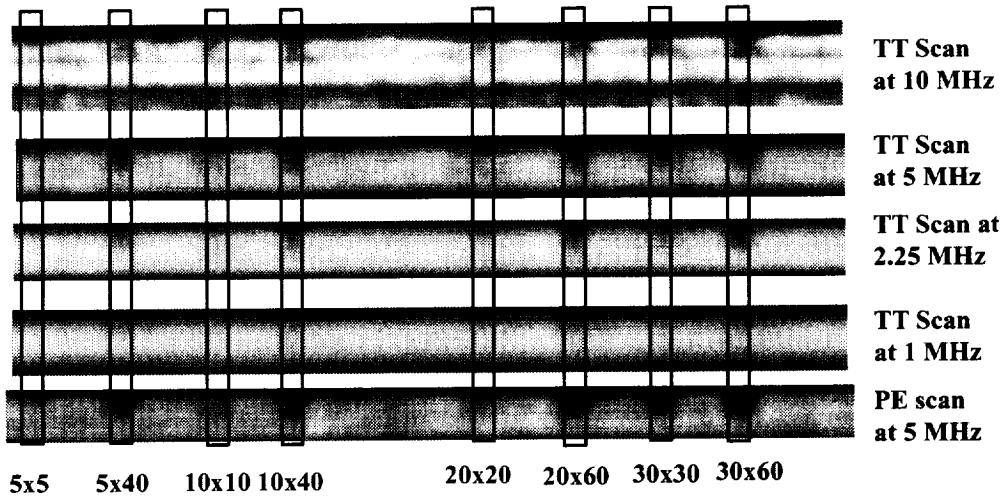
Fig. 7 - Ultrasonic scanning of one NDE ring standard showing the capabilities of detection with through transmission (TT) and pulse echo (PE) methods. The scans of the ring as displayed are open cylinders (rectangles) where the vertical direction represents the height of the ring and the horizontal direction represents the circumference from 0-359 degrees.

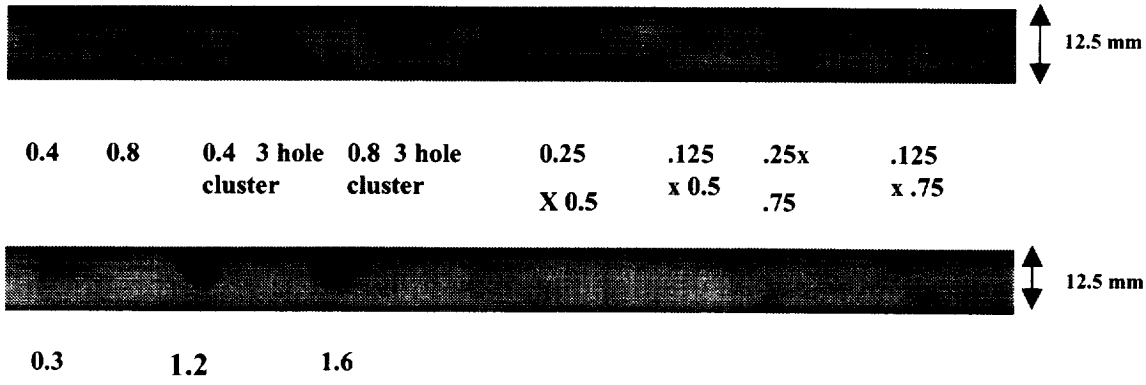
Fig. 8- Ultrasonic pulse echo (5MHz) scans of one NDE ring standard showing the capabilities of detecting 6.5mm deep EDM notches and drilled holes

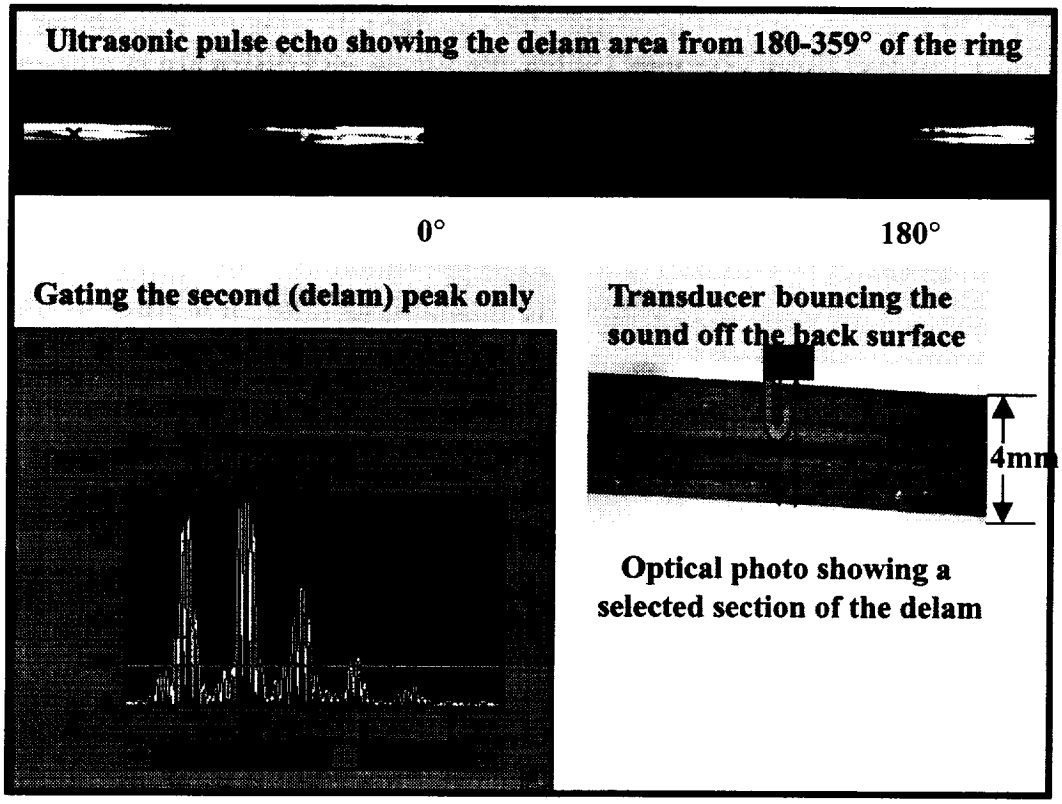
Seeded Delamination and Bagging Materials - A delamination was created in one hydroburst ring that spans 180 degrees of the circumference at midpoint in the radial direction. An optical photograph of a selected section of the delamination is shown in figure 9 where the schematic of propagating ultrasound bouncing off the I.D. surface of the ring is also depicted. The time domain of the ultrasound signal highlights the presence of the delamination, second peak, between the front surface reflection, peak 1, and back surface reflection, peak 3. Gating the second peak in the time domain, the delamination, resulted in imaging the presence of the delamination (echo coming from the wall/interface created by the delamination) between 180° and 0° (clock wise) as shown in the top of figure 9.

Ultrasonic pulse echo showing the delam area from 180-359° of the ring
0°
180°
Gating the second (delam) peak only
Transducer bouncing the sound off the back surface
4mm
Optical photo showing a selected section of the delam

Fig. 9- Immersion pulse echo ultrasonic scan of a 180 ° delam in a hydroburst ring

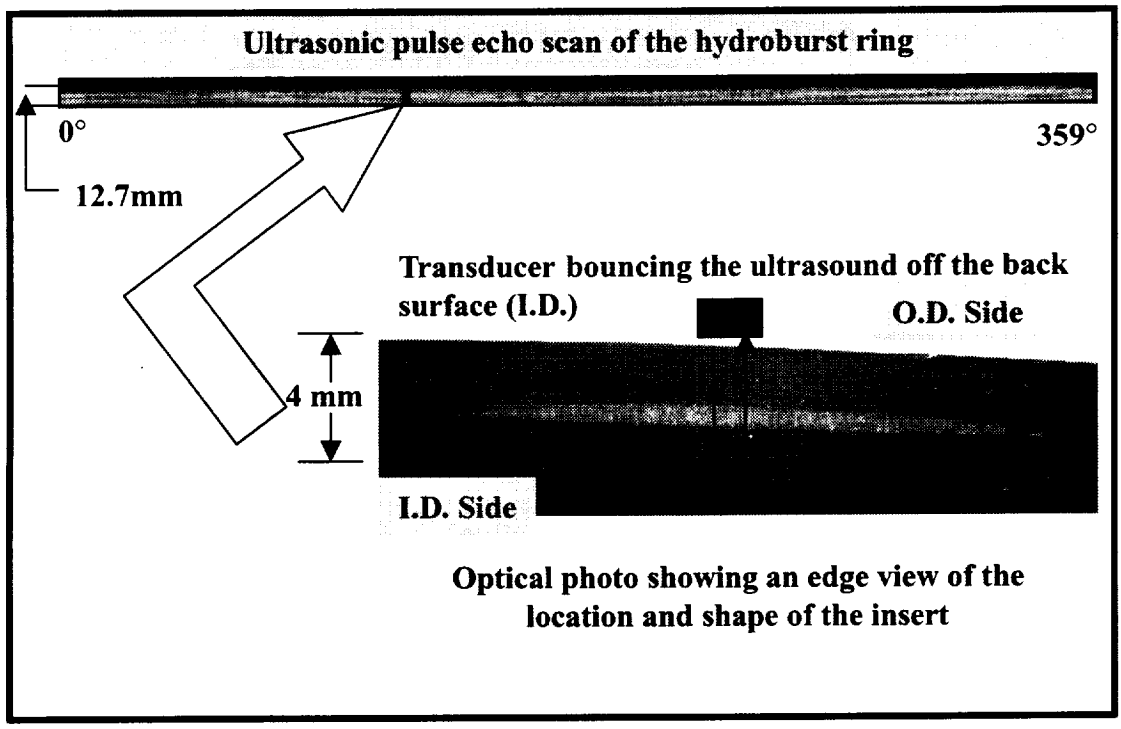
Figure 10 shows the ultrasonic PE scan of the hydroburst ring with seeded insert of bagging material located at 120 degree in the middle of the 4 mm thick by 12.7 mm wide ring. The insert was easily detected by PE ultrasonics and is depicted as a black line at the 120 °-angle location at the top of figure 10. The tow-break was simulated by an EDM notch on the ID surface of a hydroburst ring. The notches were easily detected because they were comparable to the larger EDM notches imaged in the ring standard as shown previously in figures 6-8 and Table I.

Ultrasonic pulse echo scan of the hydroburst ring
0°
359°
12.7mm
Transducer bouncing the ultrasound off the back surface (I.D.)
O.D. Side
4 mm
I.D. Side
Optical photo showing an edge view of the location and shape of the insert

Fig. 10- Immersion ultrasonic pulse echo scan detects the insert of bagging material in a hydroburst ring

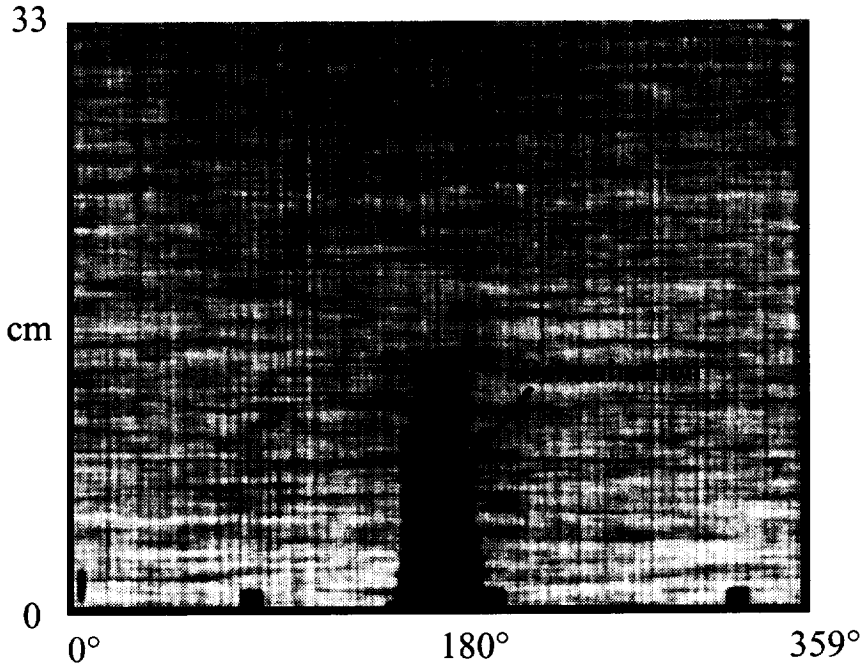
Examples of Possible Occurring Flaws - Figure 11 shows a large delamination in one of the rings as detected by PE ultrasonic method. This delamination spans a 54-degree angle near the bottom edge, and is 15 cm in height. The optical photograph of a section of the ring as exposed to the surface shows clear evidence of that delamination in figure 12. Figure 13 shows a sizeable void, about 1x2 mm (40x80 mils), at the glass-composite interface as detected by x-ray CT. The glass layer was machined off and the low-density feature as detected by CT was demonstrated to be a void. A selected area from a CT slice of a composite ring is shown in figure 14(a). The dark region, lower-density feature near the I.D., depicts the presence of a resin rich area. After the ring was sectioned destructively and the specific location was exposed to the surface and polished, the optical photograph (Fig. 14b) confirms the CT findings of the resin rich area.

Fig. 11 - Ultrasonic scan showing a large delamination in one of the rings

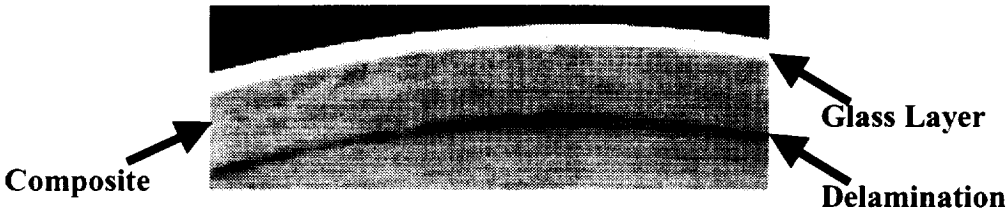
Fig. 12 - Optical photograph of a section of the ring showing the delamination (Fig. 11) as exposed to the surface

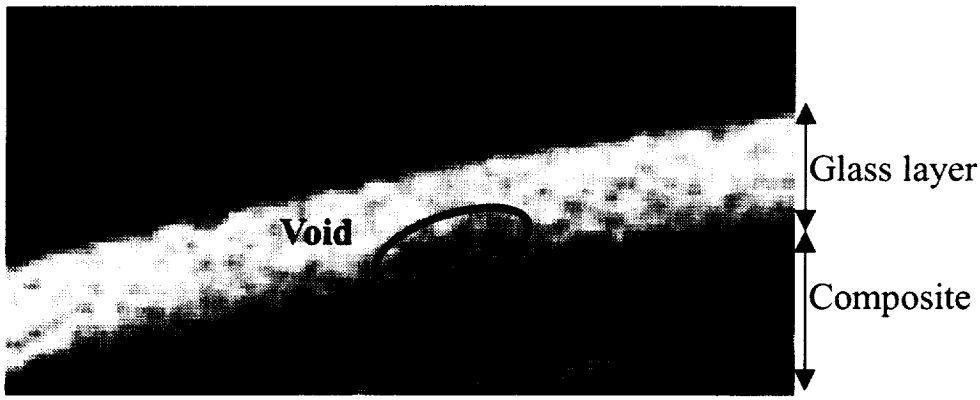
Fig. 13 - Selected section from the CT scan showing a 40x80 mils void in the glass layer

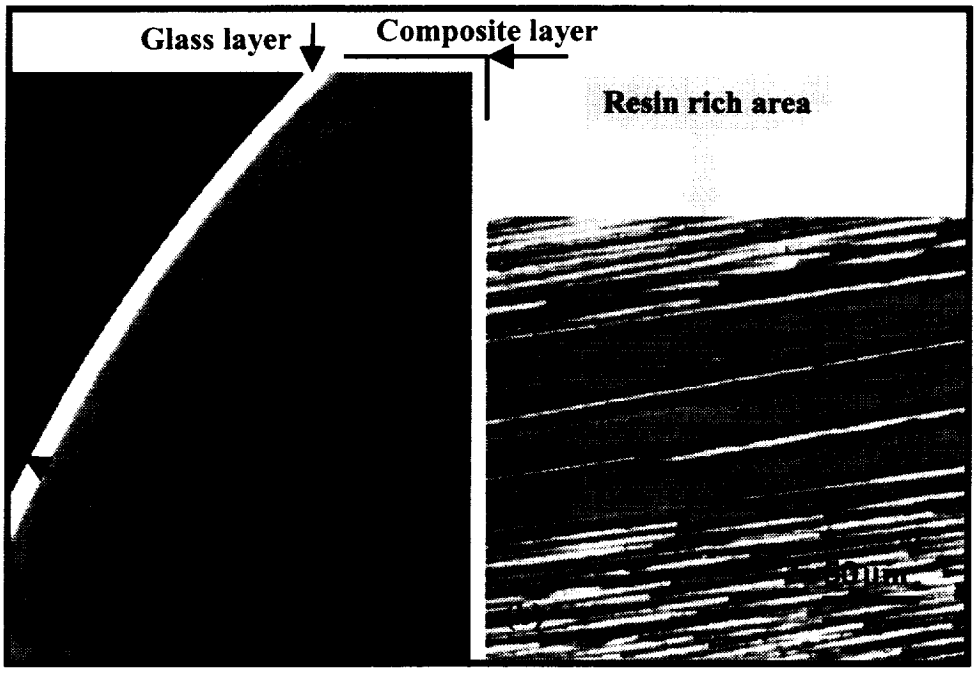
Fig. 14- Selected area from a computed tomography cross section showing a resin rich region within the composite layer (a), and an optical photograph of the resin rich region after destructive sectioning and polishing for validation (b)
